**Technical Enforcement Support
at Hazardous Waste Sites
Zone III
Regions 5,6, and 7**

**PRELIMINARY ASSESSMENT/
VISUAL SITE INSPECTION**

**NATIONAL CASTINGS INCORPORATED
CICERO, ILLINOIS
ILD 049 015 134**

FINAL REPORT

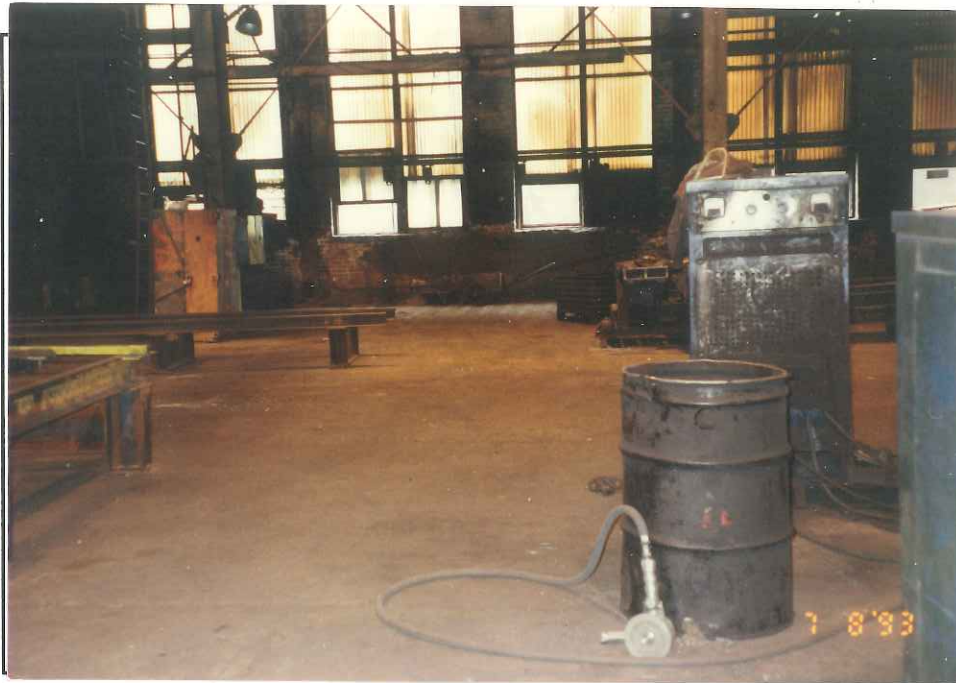
Photograph No. 1

Observations: This unit was inactive at the time of the VSI. The concrete floor of this unit was not cracked. A trench covered with 18 inch square steel plates was located 6 feet east of this unit. There was no water in this trench at the time of the VSI. PRC noted no evidence of release (see Photographs No. 1 and 2).

Description: This photograph shows the Former Hazardous Waste Storage Areas. The steel drum in the foreground is used for trash collection.

Location: SWMU 1

Recommendations: PRC recommends no further action for this SWMU at this time.

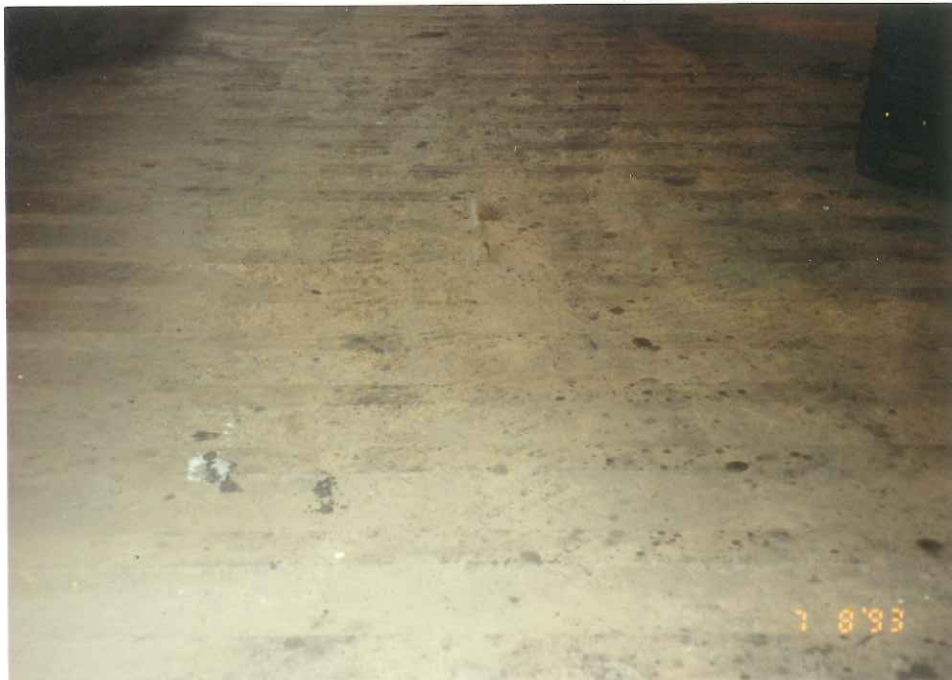
Photograph No. 2

Description: This photograph shows the floor of the Former Hazardous Waste Storage Areas.

Location: SWMU 1

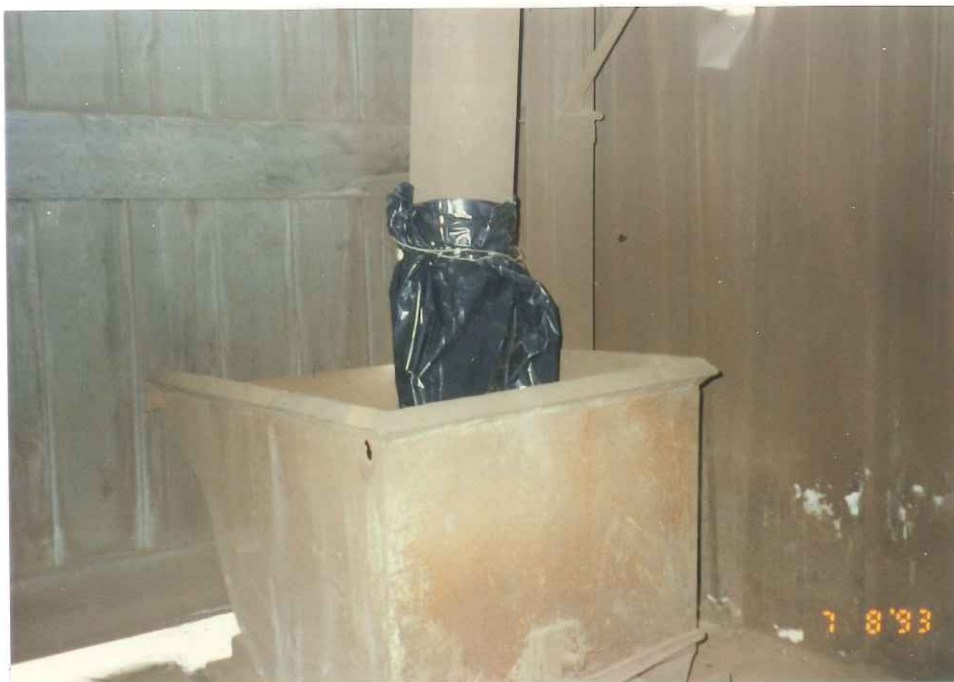
Photograph No. 3
 Orientation: North
 Description: This photograph shows Baghouse Dust Collector 1.

Observations: This unit was in operation at the time of the VSI. The baghouse dust collectors were partially filled at both baghouses. PRC noted no evidence of release (see Photographs No. 3 and 4).

Location: SWMU 2
 Date: July 8, 1993

Recommendations: PRC recommends no further action for this SWMU at this time.

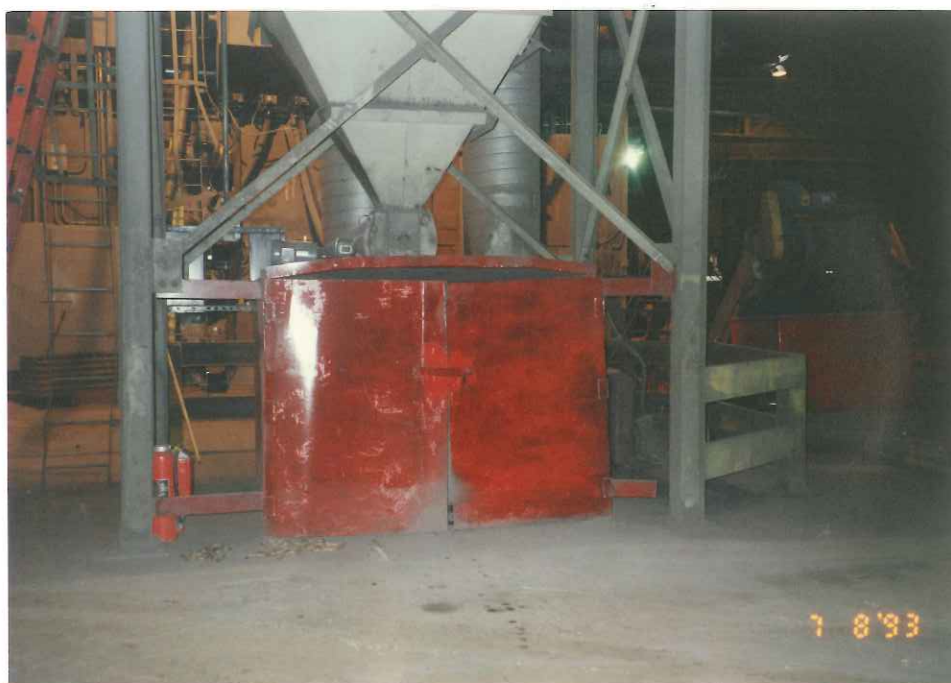
Photograph No. 4
 Orientation: West
 Description: This photograph shows Baghouse Dust Collector 2.

Location: SWMU 2
 Date: July 8, 1993

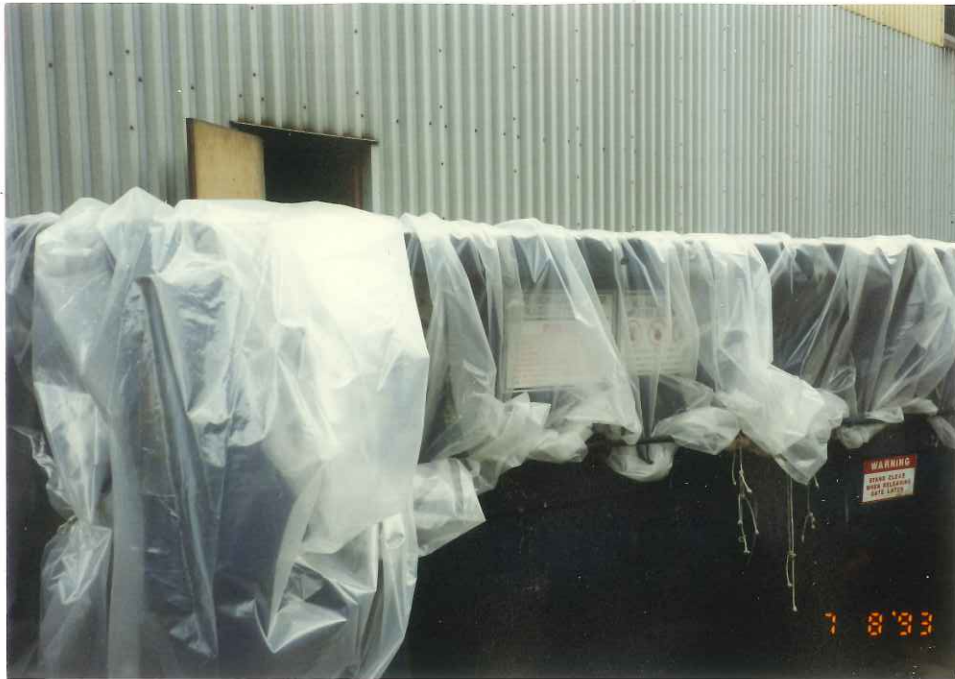
Photograph No. 5

Observations: This unit was active at the time of the VSI. Two roll-off boxes were observed. One roll-off box was lined with plastic and contained plastic bags filled with baghouse dust. A second roll-off box was partially filled with slag and used sand. PRC noted no evidence of release (see Photographs No. 5 and 6).

Description: This photograph shows a plastic lined roll-off box used to collect baghouse dust at the Baghouse Dust, Slag, and Waste Firebrick Storage Area.

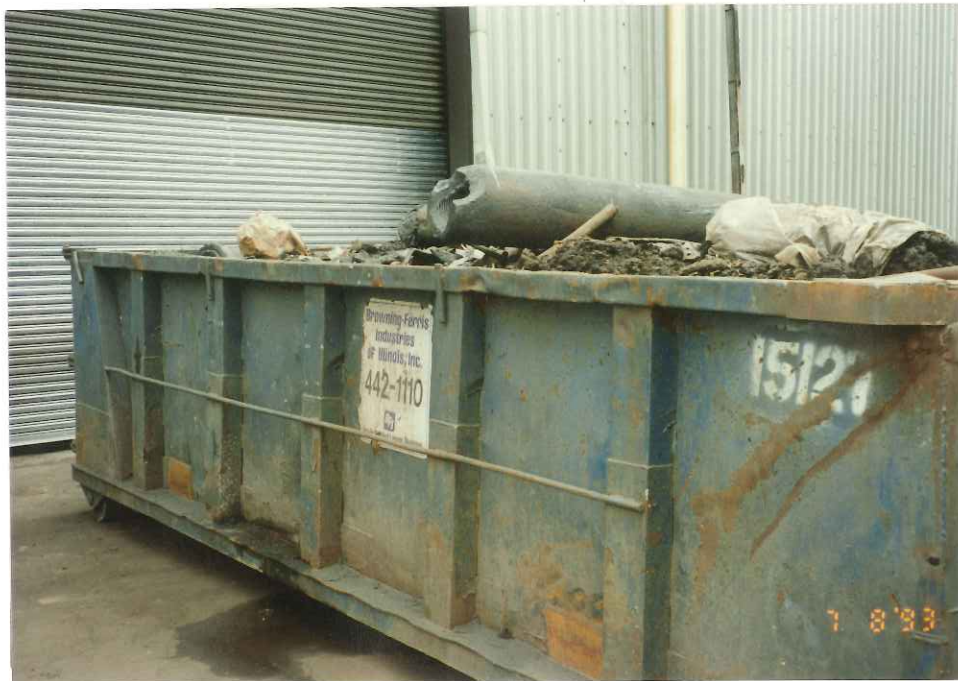
Photograph No. 6

Description: This photograph shows a roll-off box used to collect slag at the Baghouse Dust, Slag, and Waste Firebrick Storage Area.

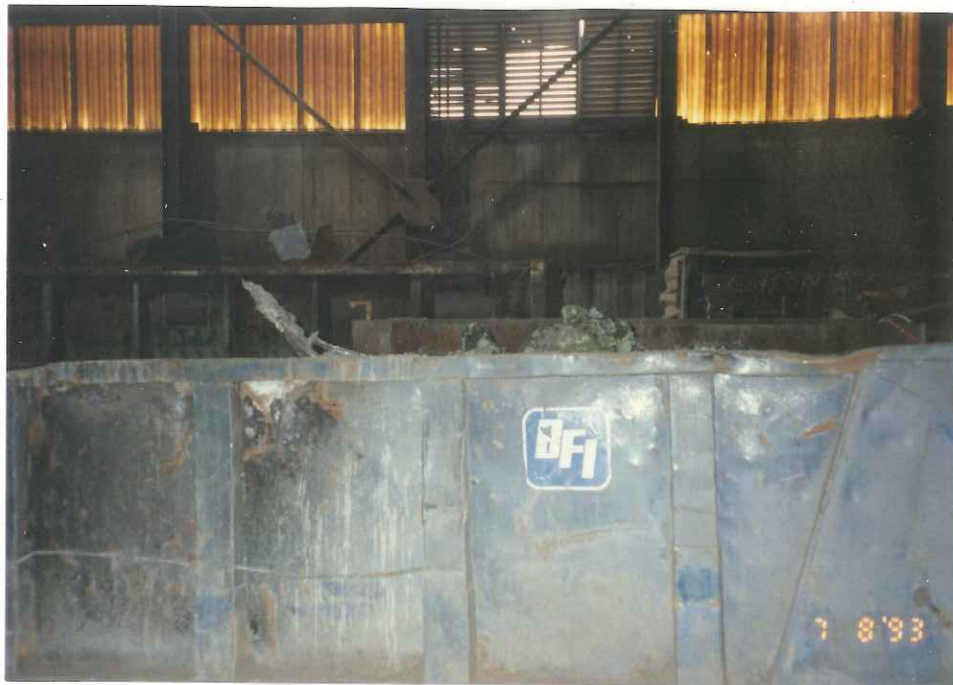
Photograph No. 7

Observations: This unit was in operation at the time of the VSI. The roll-off box was partially filled with slag. PRC noted no evidence of release (see Photograph No. 7).

Location: SWMU 5

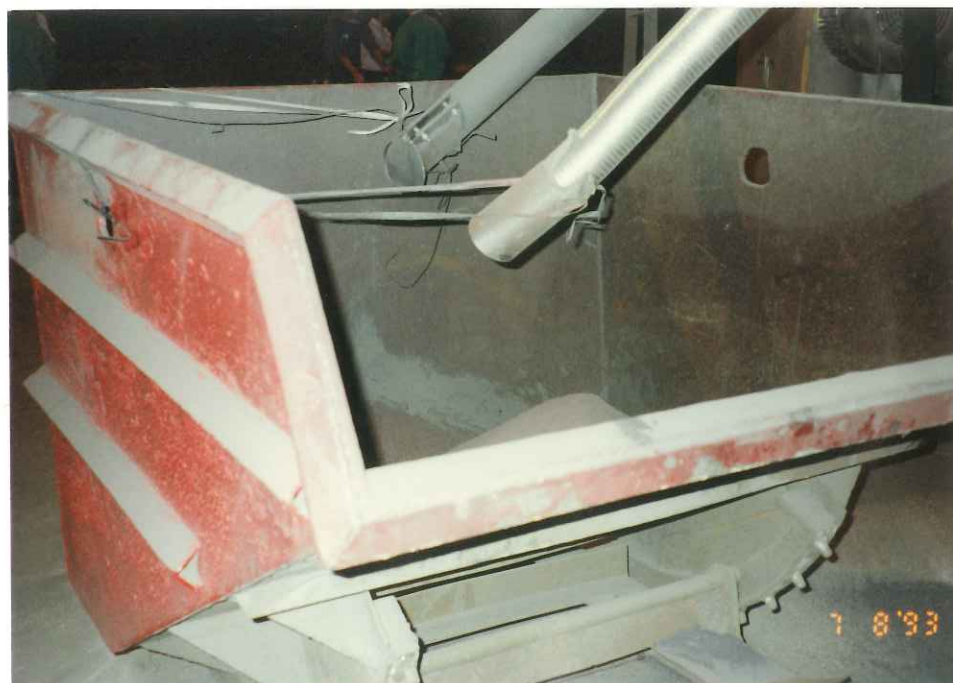
Photograph No. 8

Location: SWMU 6

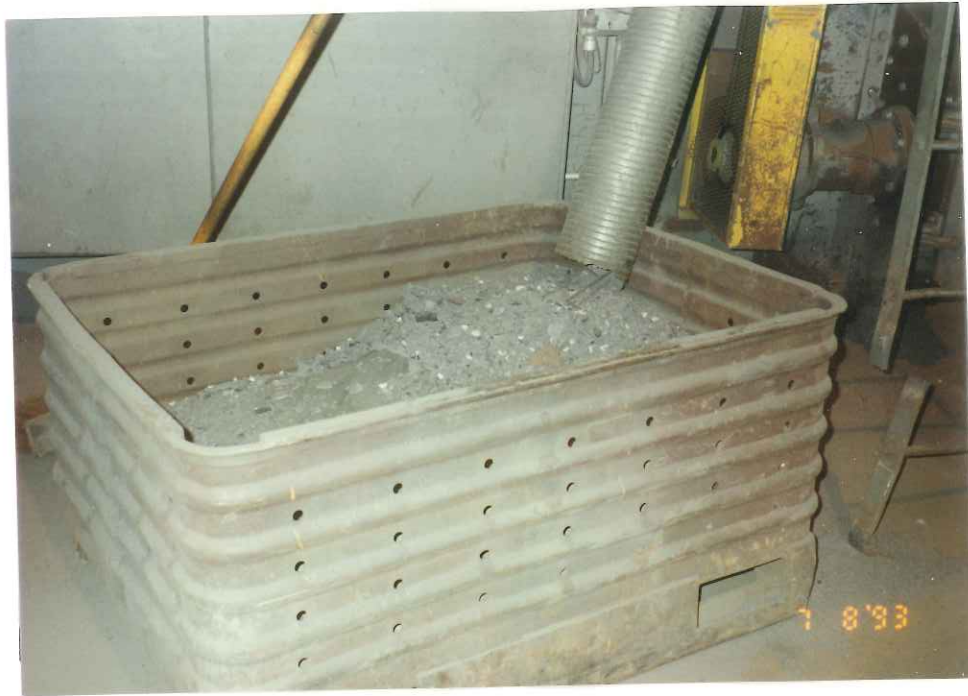
Photograph No. 9

Location: SWMU 6

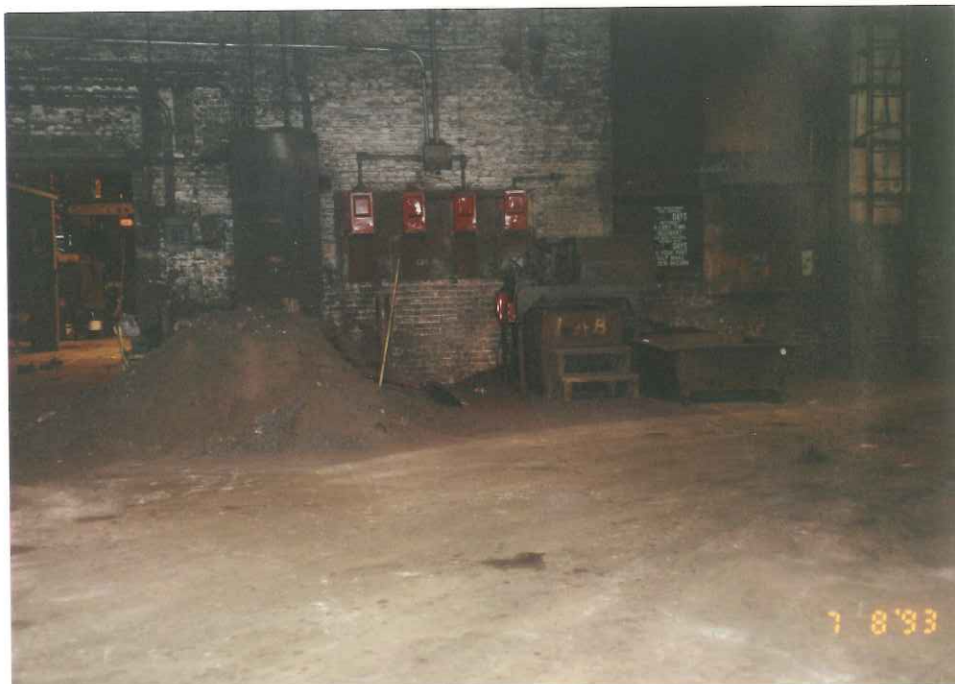
Photograph No. 10

Location: SWMU 6

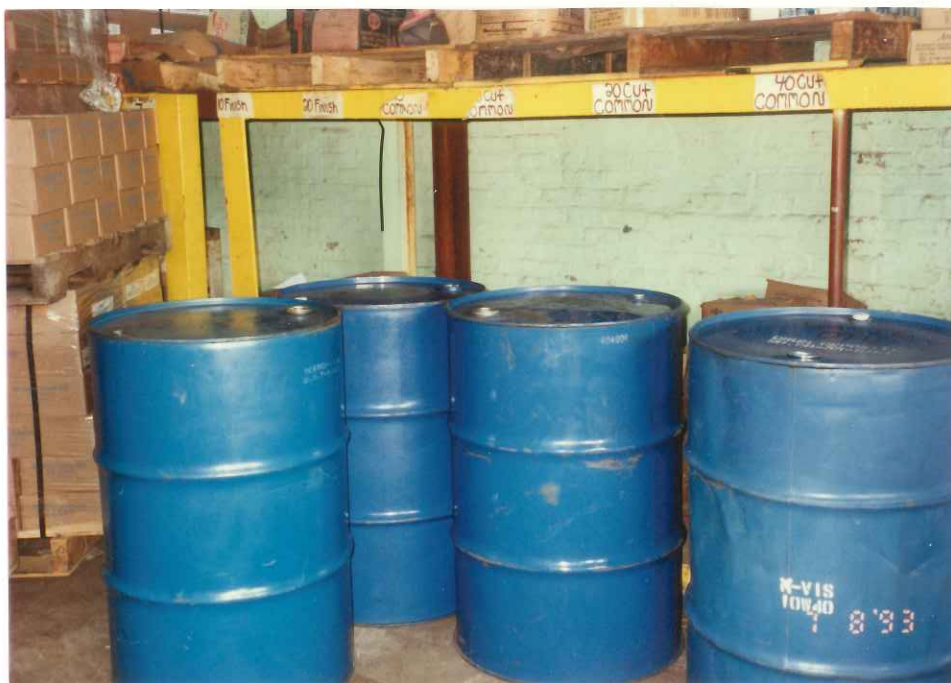
Photograph No. 11

Observations: At the time of the VSI, this unit contained four empty 55-gallon, steel drums and various products used by the facility which were stored on pallets. PRC noted no evidence of release (see Photograph No. 11).

Location: SWMU 7

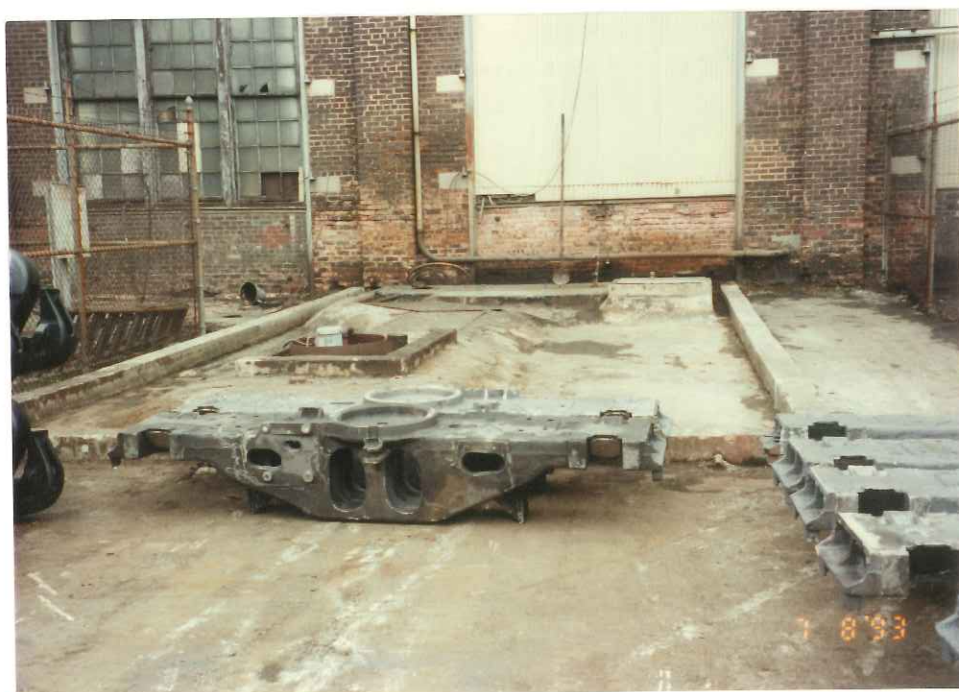
Photograph No. 12

surrounding the area. PRC noted no evidence of release (see Photograph No. 12).
